Cheriton Church

A Brief History of the Building

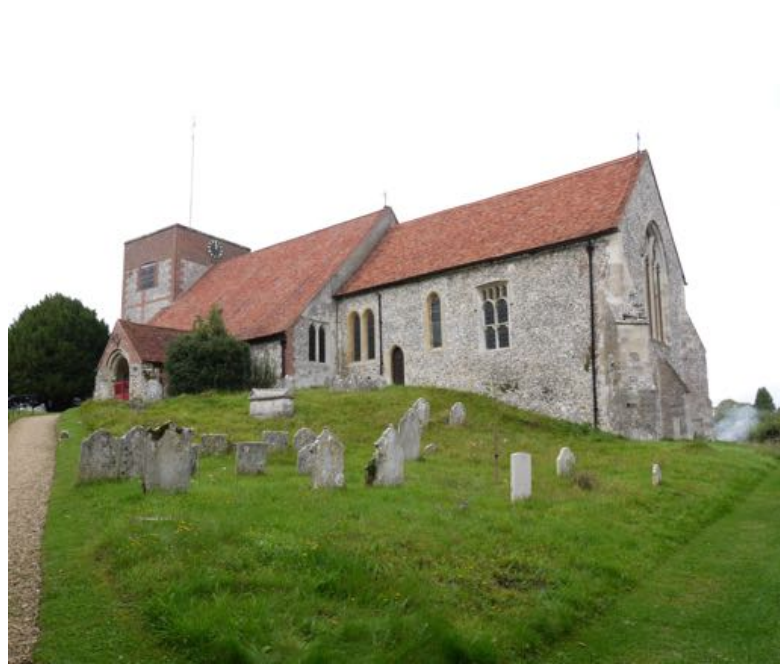
1.

- 1.** Cheriton church is built on a man-made mound which must have existed before the church was built in the 12th century and which has the appearance of a prehistoric round barrow, perhaps dating to 1,000-2,000 B.C. Note how the east end of the chancel is built over a slope (See 5 below).

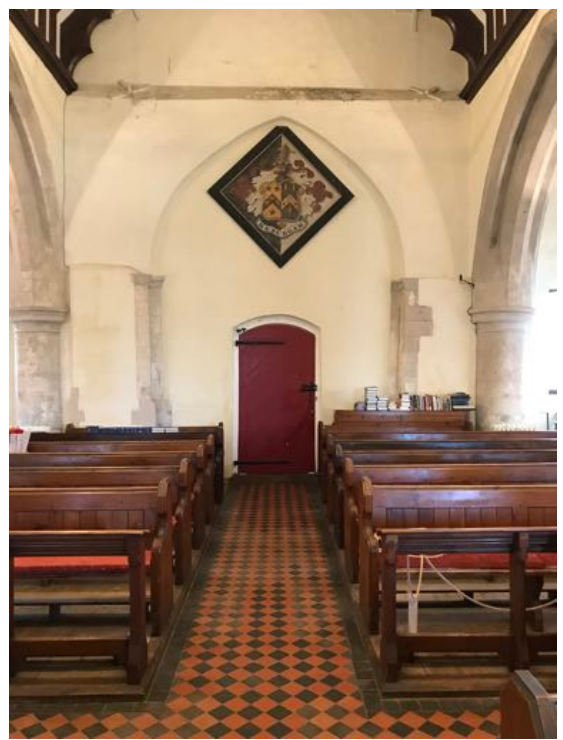
2.

- 2.** The oldest parts of the church, according to a recent study, are two square attached columns of the 12th century which flank the tower arch at the west end of the nave. This early church may have lacked aisles.

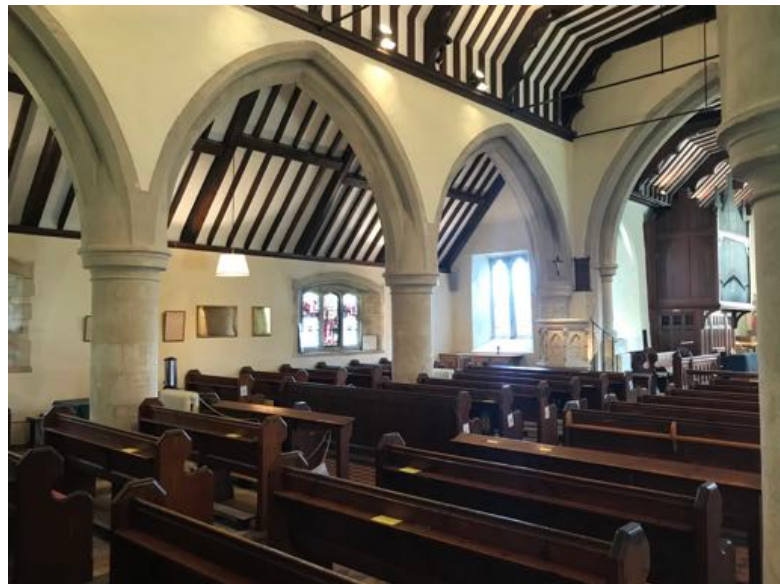
3.

- 3.** The nave belongs to the early 13th century. It has fine 3-bay arcades with round columns. This new (or remodelled) church with aisles would have accommodated a large congregation at a time when the population was growing rapidly.

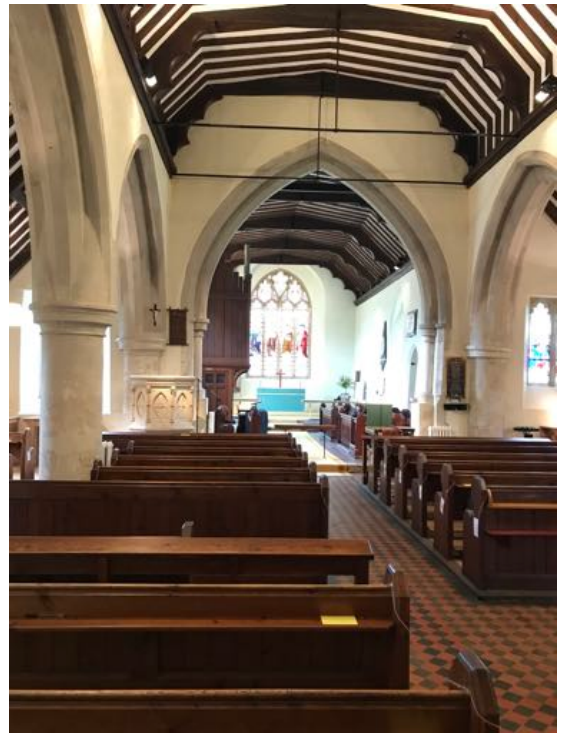
4.

- 4.** The fine chancel arch and the chancel itself as far as the step before the altar also belong to the early 13th century. Of the same date are the priest's door and 'lancet' windows in the chancel. The large East window dates to the late 14th century, though the stained glass was added in 1881 as a gift from the Rector at the time, the Reverend Alexander Orr.

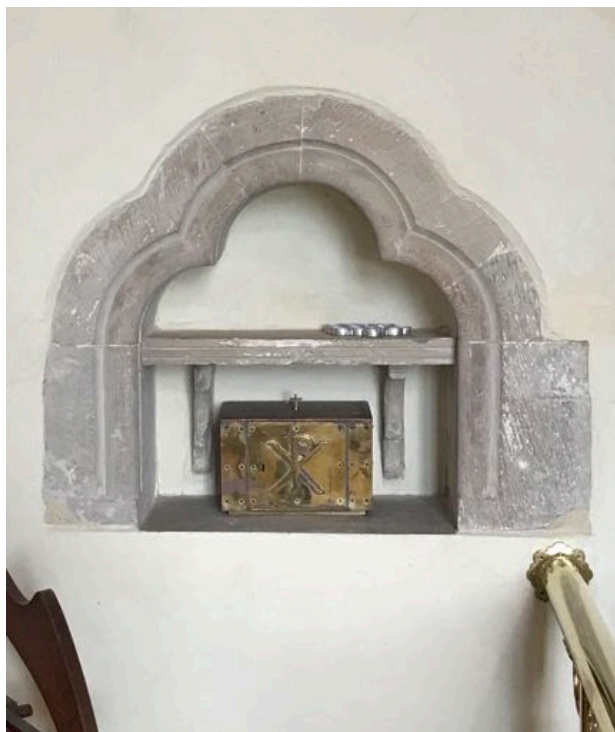
5. In the 13th century, a Papal Council stressed the belief that the bread and wine at Communion became Christ's body and blood. This gave added sanctity to the vessel in which the wine was held and to the place where this transformation of the wine took place. As a result, the chancel was extended beyond the altar step and, among other changes, a 13th century piscina was placed there in which the holy vessel was washed.

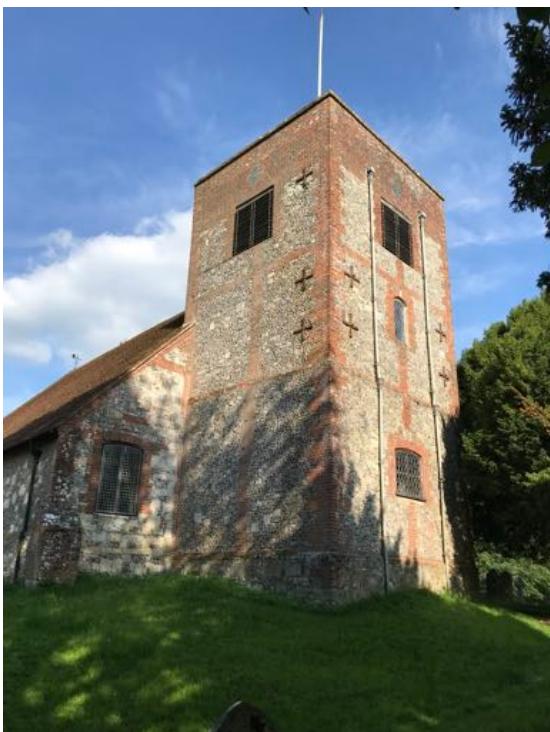
6. In 1744, the Church Register recorded that 'a very sudden and terrible fire broke out in this parish'. The church tower was severely damaged by the fire and had to be rebuilt with 18th century bricks to consolidate the flintwork.

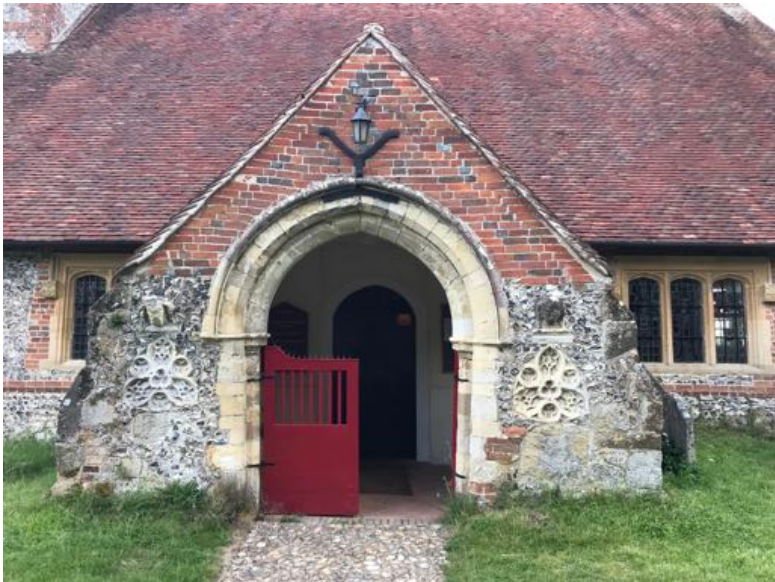
7. The porch was also built or rebuilt with 18th century bricks after the fire and some fine early 14th century carvings were applied to its front.
8. The carvings on the porch front includes male and female heads (perhaps a king and queen) and swirling tracery. These carvings come from a high-status building, but where? Possibly from Bishop's Sutton palace nearby which was in a ruinous state in the 18th century.

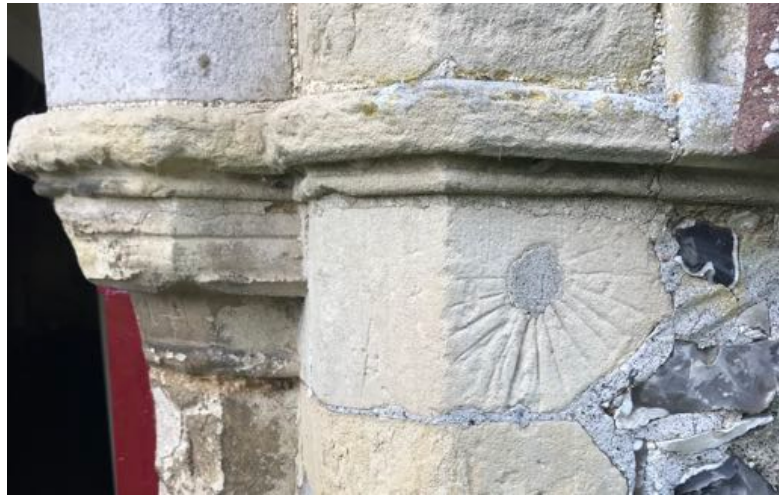
9. Also on the front of the porch is this medieval mass dial, also known as a scratch dial because the lines were scratched into the stone. The central hole originally held a pin which cast a shadow to indicate the time for masses (or catholic church services).

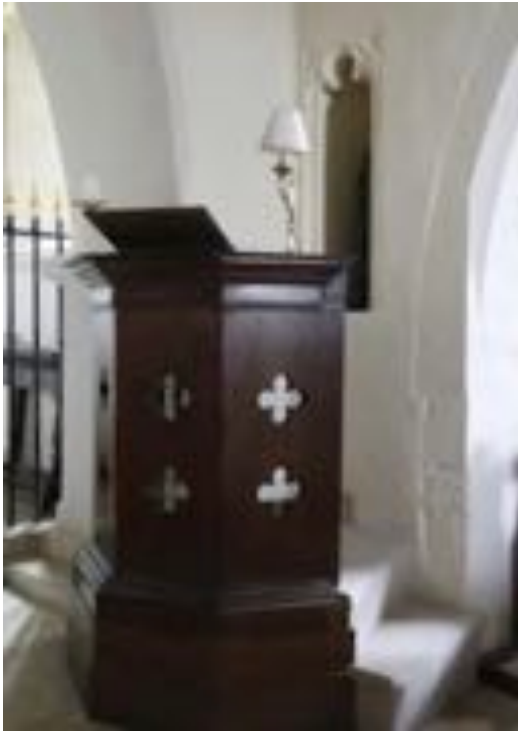
10. After the fire of 1744 a new pulpit was needed. The pulpit in this picture was replaced in 1879 when the church was 'restored'. It is now in Tichborne church.

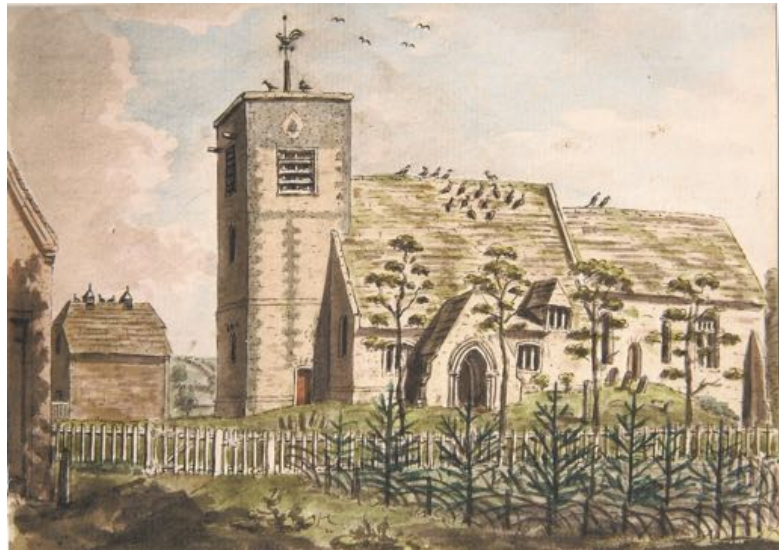
11.

- 11.** This picture of the church was drawn in 1784. A Glebe terrier of 1635 (a record of all the church possessions) lists buildings belonging to the Rectory including 'A Double Pigeon House in the Church Yard.' In the picture, this pigeon house may be seen between the rectory wall (far left) and the church. The pigeons on the roof may have soon gone into the rector's pigeon pie!
